2. SEE SHEET T1.1 FOR TYPICAL GENERAL NOTES.
3. THE CLUBHOUSE IS CONSTRUCTED OF CEDAR LOGS RANGING IN APPROXIMATE DIAMETER FROM 6" TO 8½". THE LOGS ARE SET WITH TIGHT JOINTS, LAPPED AND SPIKED AT THE CORNERS ("BUTT-AND-PASS JOINTS"). THE VERTICAL LOGS

GENERAL SCOPE OF WORK:

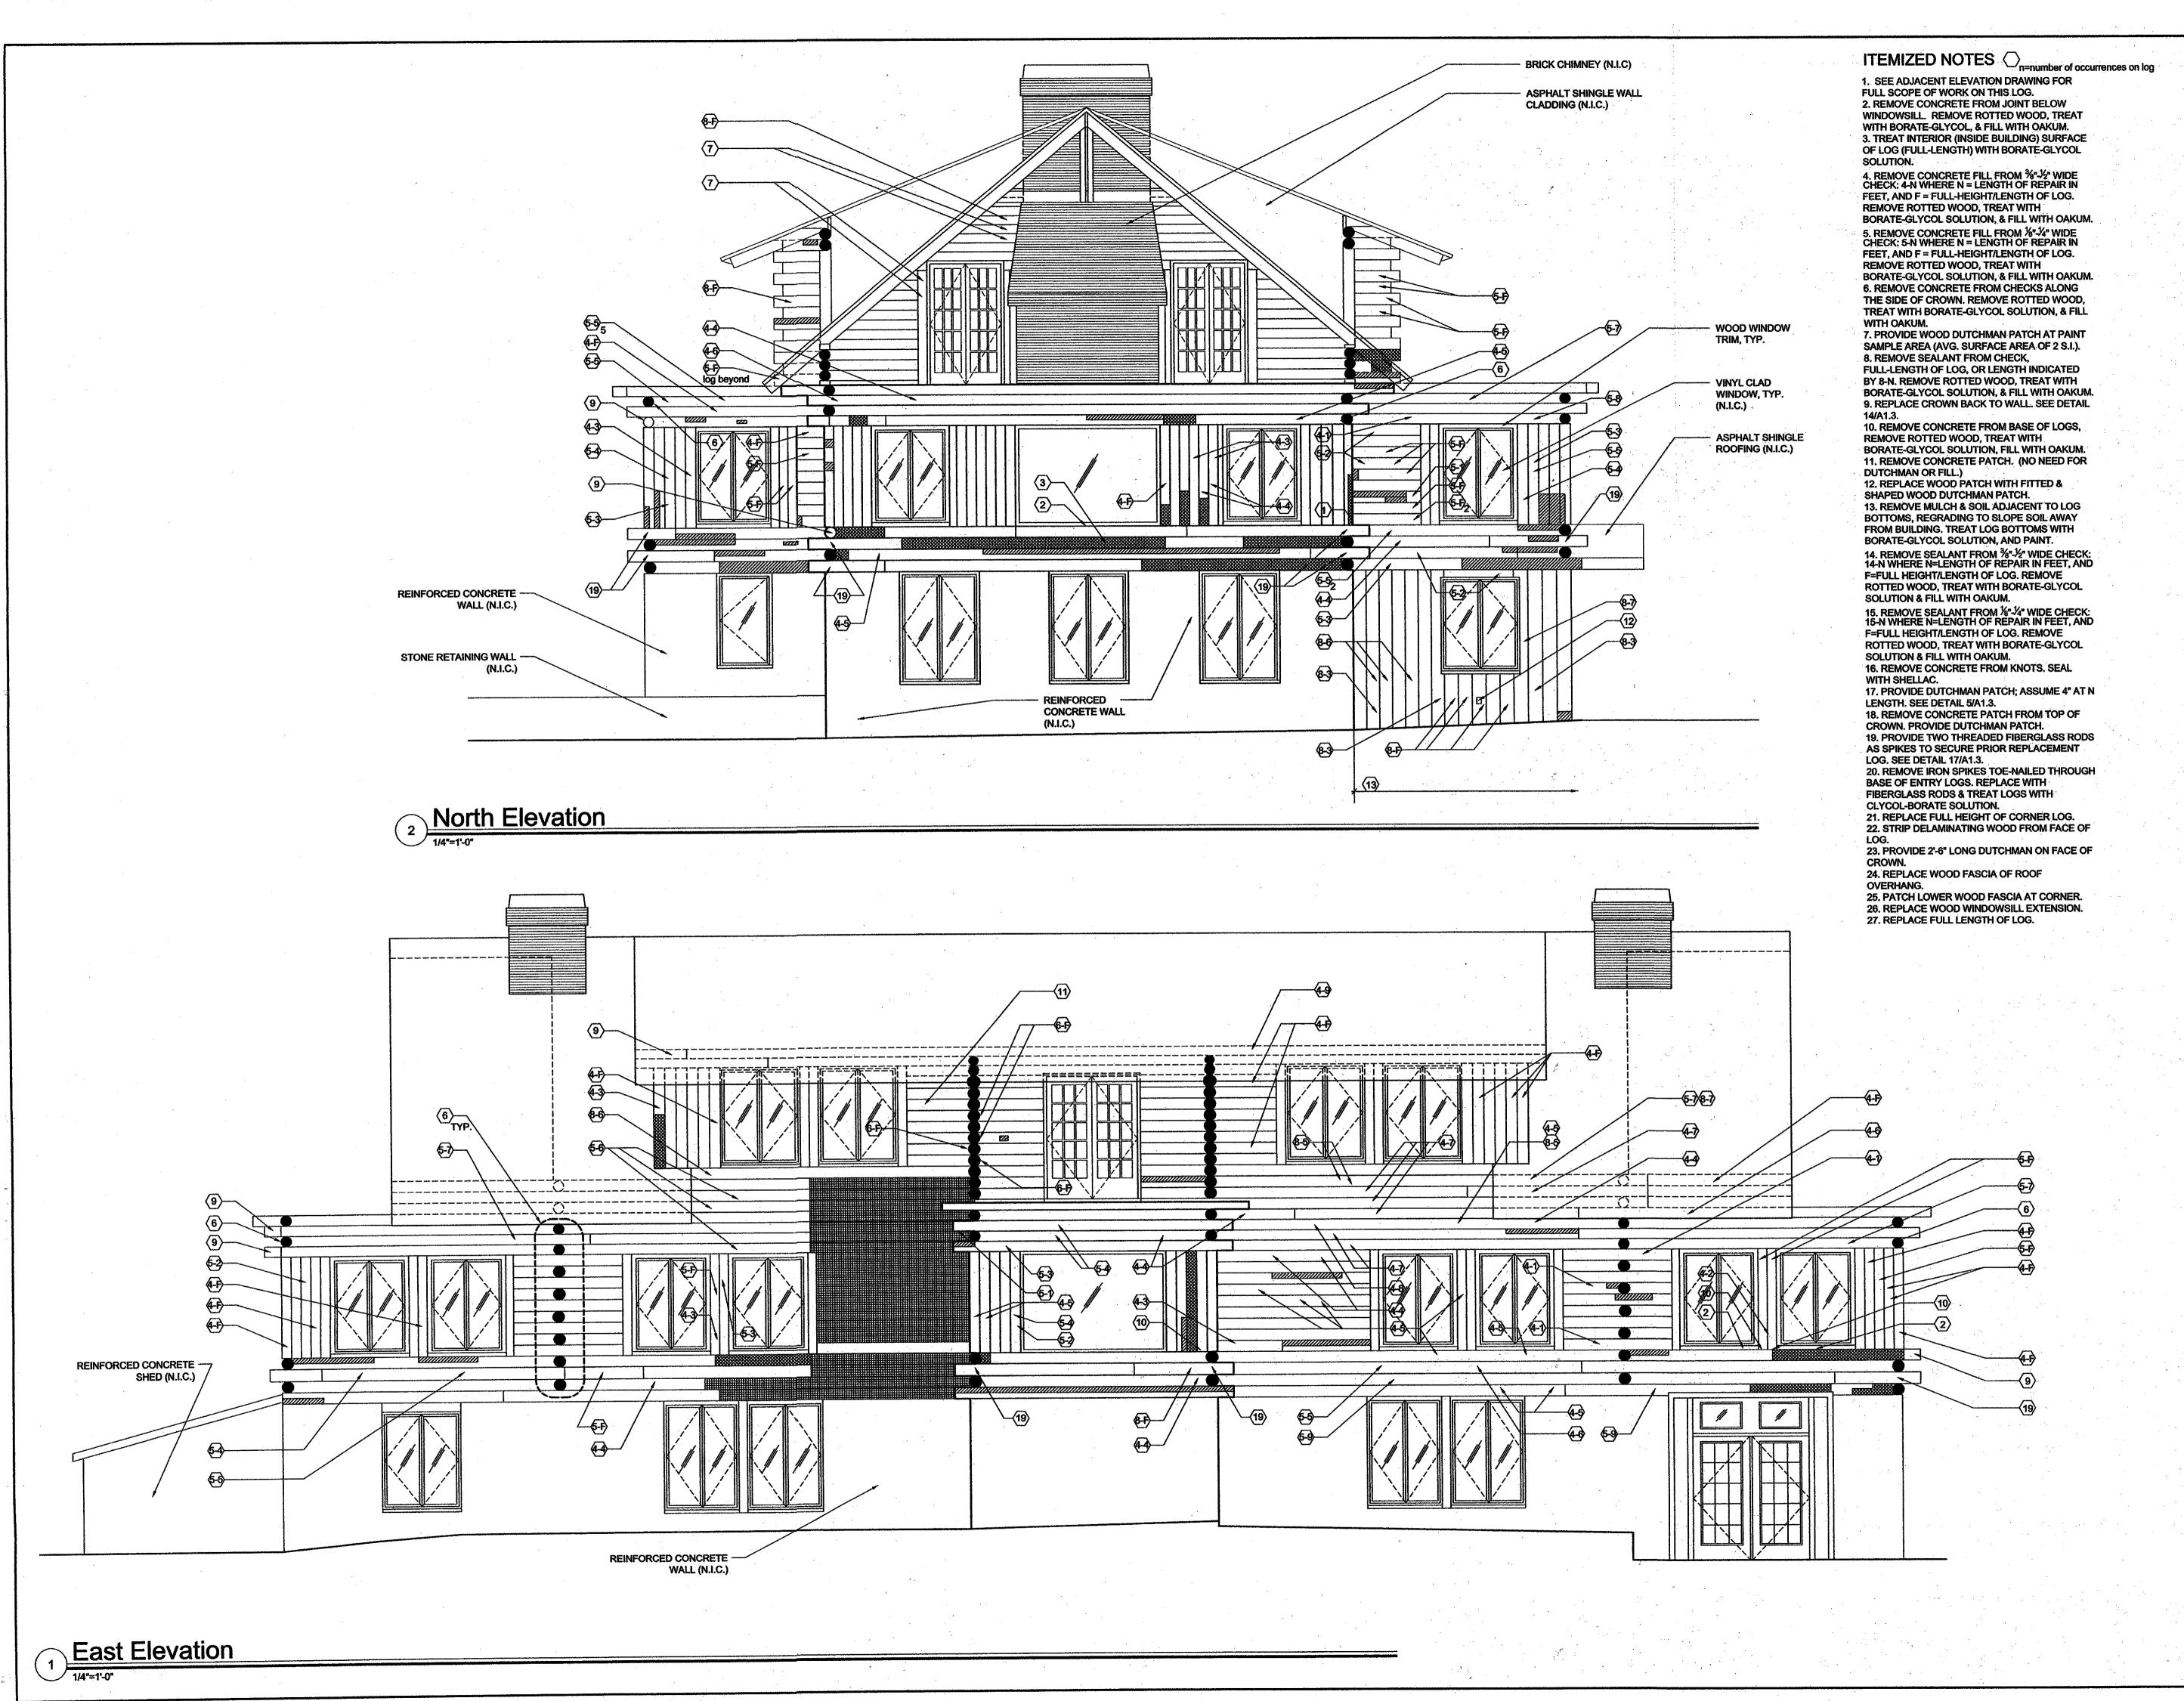
ARE FASTENED WITH SPIKES AT BASE AND TOP.

ALL THE WORK NOTED BELOW APPLIES TO ALL EXTERIOR WOOD SURFACES (LOGS, EXPOSED RAFTERS, AND TRIM):

4. REMOVE CONCRETE PATCHES AS IDENTIFIED IN ITEMIZED NOTES & AS INDICATED BY LEGEND.
5. INSERT BORATE RODS INTO ALL CROWN ENDS AND PLUG WITH PT WOOD DOWEL. SEE 19/A1.3.
6. STRIP PAINT FROM EXTERIOR OF LOGS AND WINDOW TRIM (OF ALL 3 FLOORS), THEN CLEAN AS SPECIFIED. COAT ALL EXTERIOR SURFACES OF LOGS AND WINDOW TRIM WITH BORATE SOLUTION, & WATER REPELLENT PRESERVATIVE STAIN FINISH.

7. AFTER APPLICATION OF PAINT SYSTEM, PACK OAKUM INTO ALL INTERIOR & EXTERIOR JOINTS IMPACTED BY LOG RESTORATION, AND INTO CHECKS THAT FACE UP.

8. WHERE REPLACING PORTION OF LOG AT CORNER, SEE DETAILS 15 & 16/A1.3.

REMOVE CONCRETE PATCH. PROVIDE WOOD DUTCHMAN (5/A1.3), ½ LOG FACE REPLACEMENT (6/A1.3), OR FULL LOG FACE REPLACEMENT (13/A1.3)
